**REPORT ON CONDITION
SURVEY**

**ABERDYFI WHARF
GWYNEDD**

GWYNEDD COUNCIL

MARCH 2010

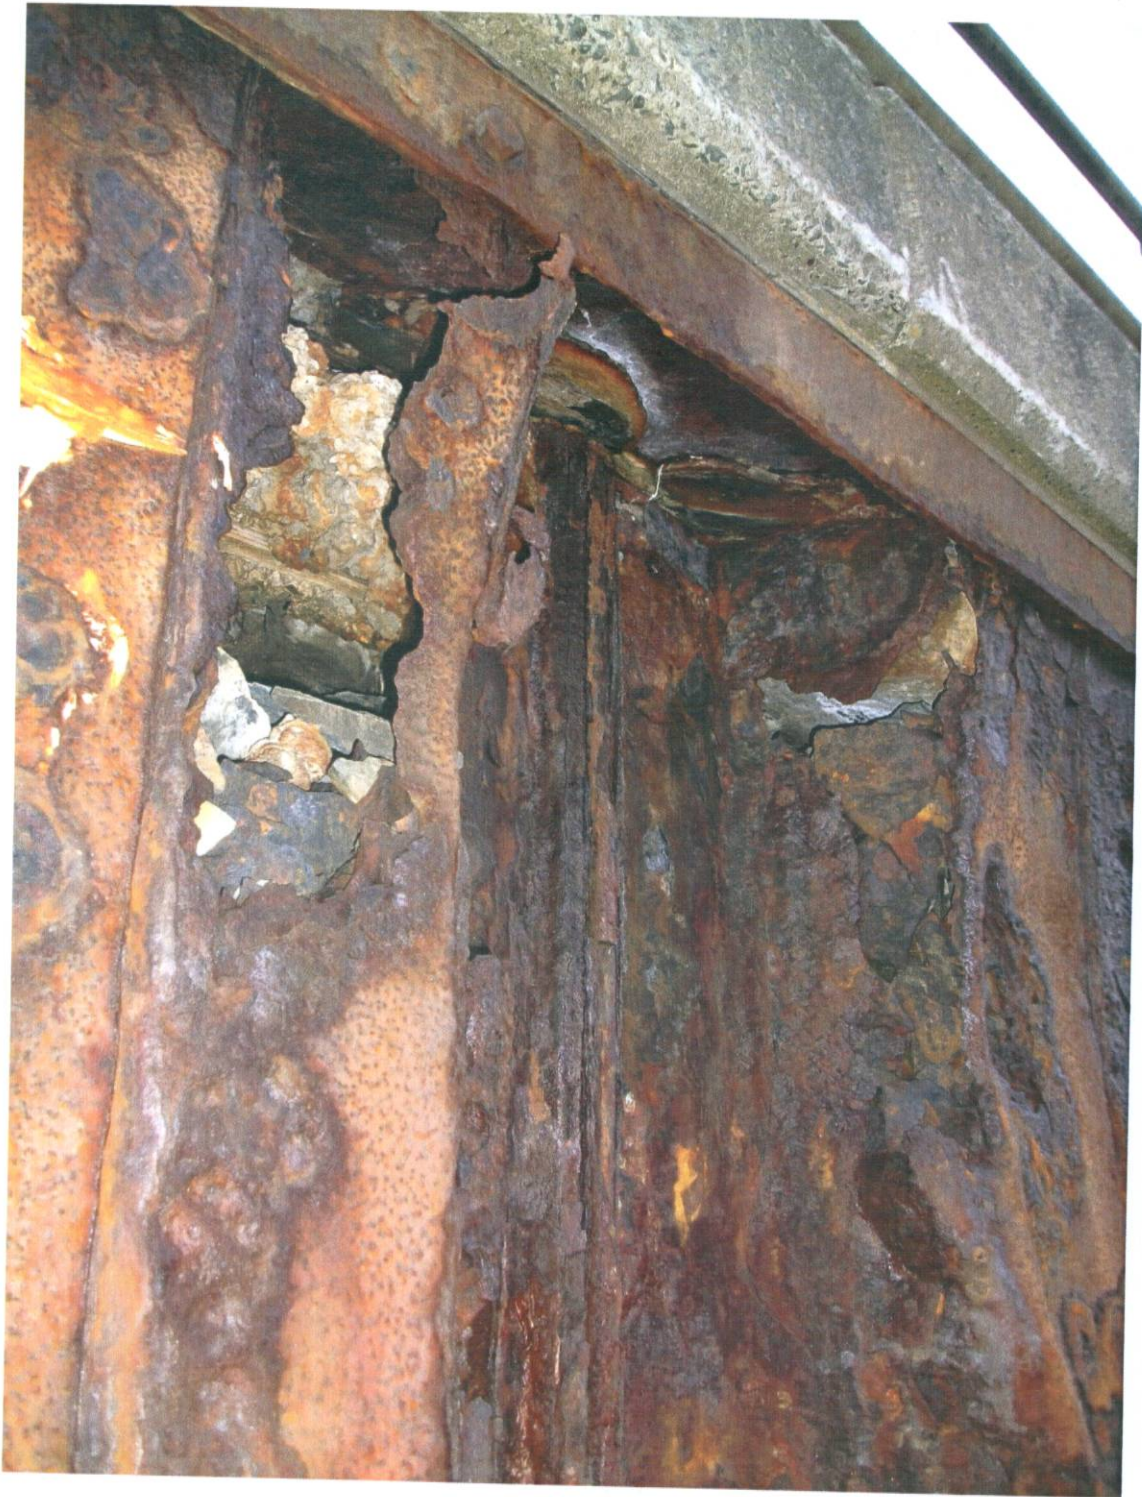
- 4.8 On the South face, East end the sheet piling appears to have suffered some impact damage, see photograph in appendix A.

- 5.5 On the South face, East end the impact damage, with reference to the photographic plate number 4 from our April 2006, this area needs to be repaired.

Impact damage to top of wharf wall.

- 6.2 Repairs which should be undertaken within the next 6 months, re-fix bottom of anode on the east face (4.7) and repair impact damage to the top section of the piling on the south face near to the SE corner (4.8 and 5.5)

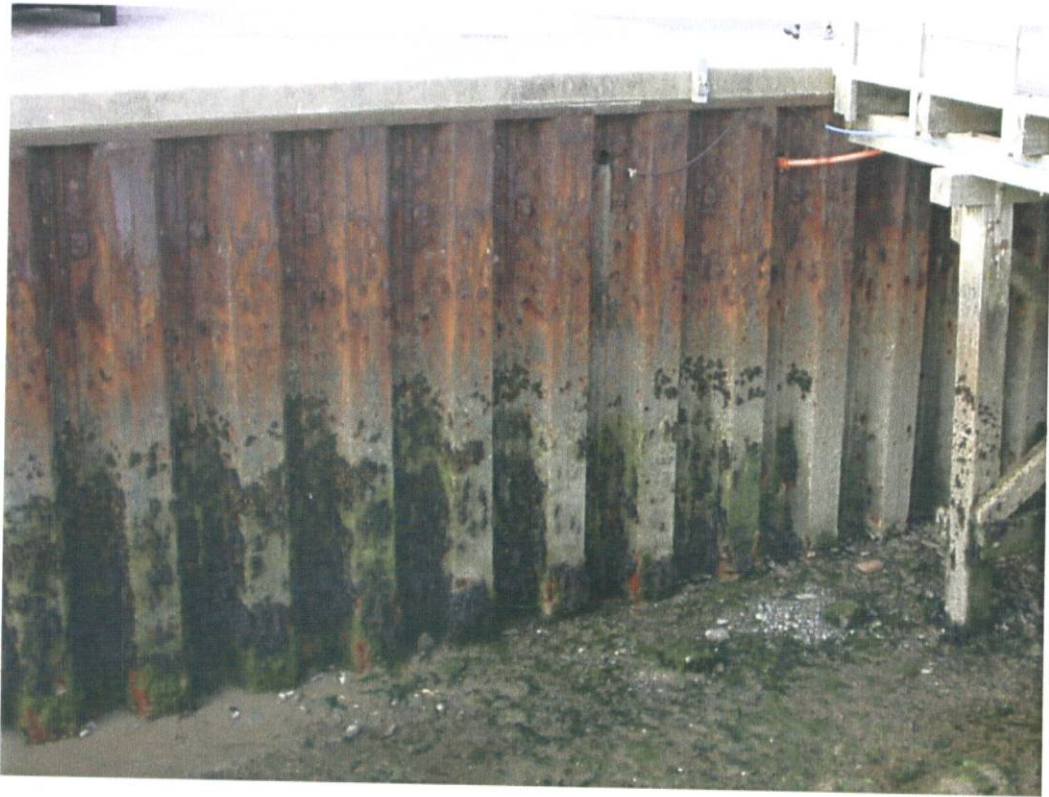
- 5.4 During our inspection the absence of bright orange deposits suggests that the anodes have arrested the Accelerated Low Water Corrosion (ALWC) see comparison photographs, August 2003 and March 2010, in appendix A.

August 2003, note bright orange deposits at bottom of piling.

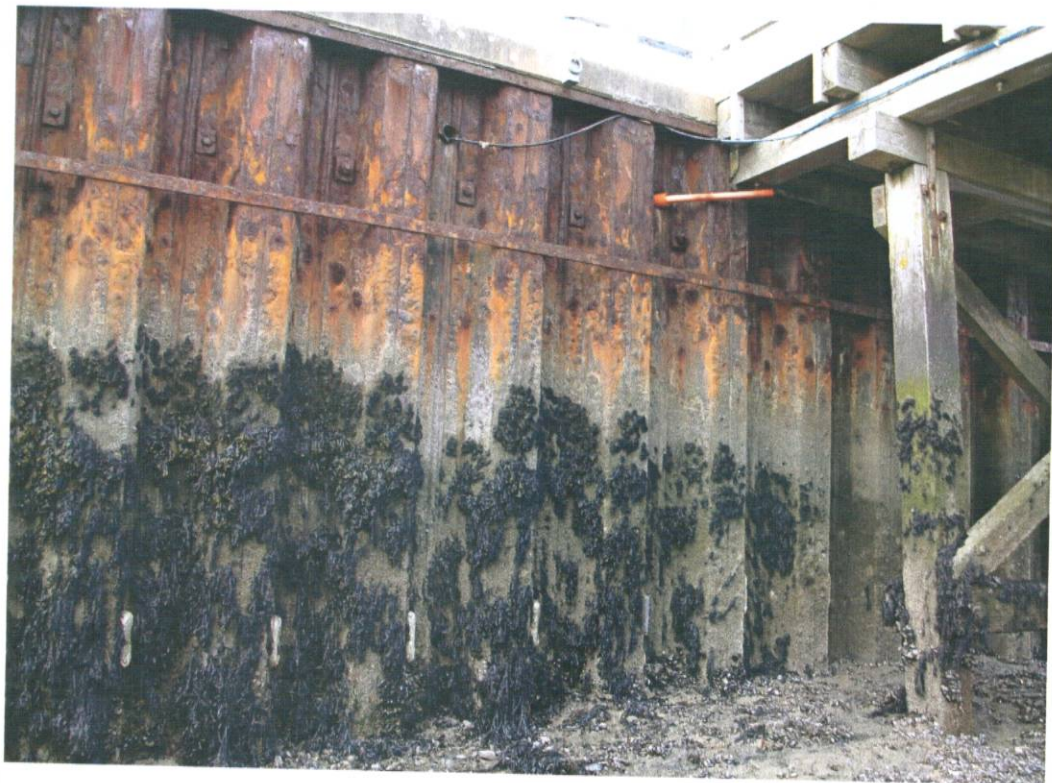
- Inter Tidal Zone - thickness ranged from 5.9mm to 9.4mm with an average of 8.0mm.
 - Accelerated Low Water Corrosion Zone – this appears to have been arrested in that no bright orange surface deposits were noted. Thickness readings in the range 4.9mm to 5.9mm were recorded.

March 2010, No bright orange deposits.
