CPD Talycaen Cells  
Gloeddia Gla, Talycaen,  
Gwynedd, LL54 6BY

Cynllunio Uroliad  
Location Plans

Cymru Safle Arfaethdiga  
Proposed Block Plan

Sied Arfaethedig  
Proposed Shed

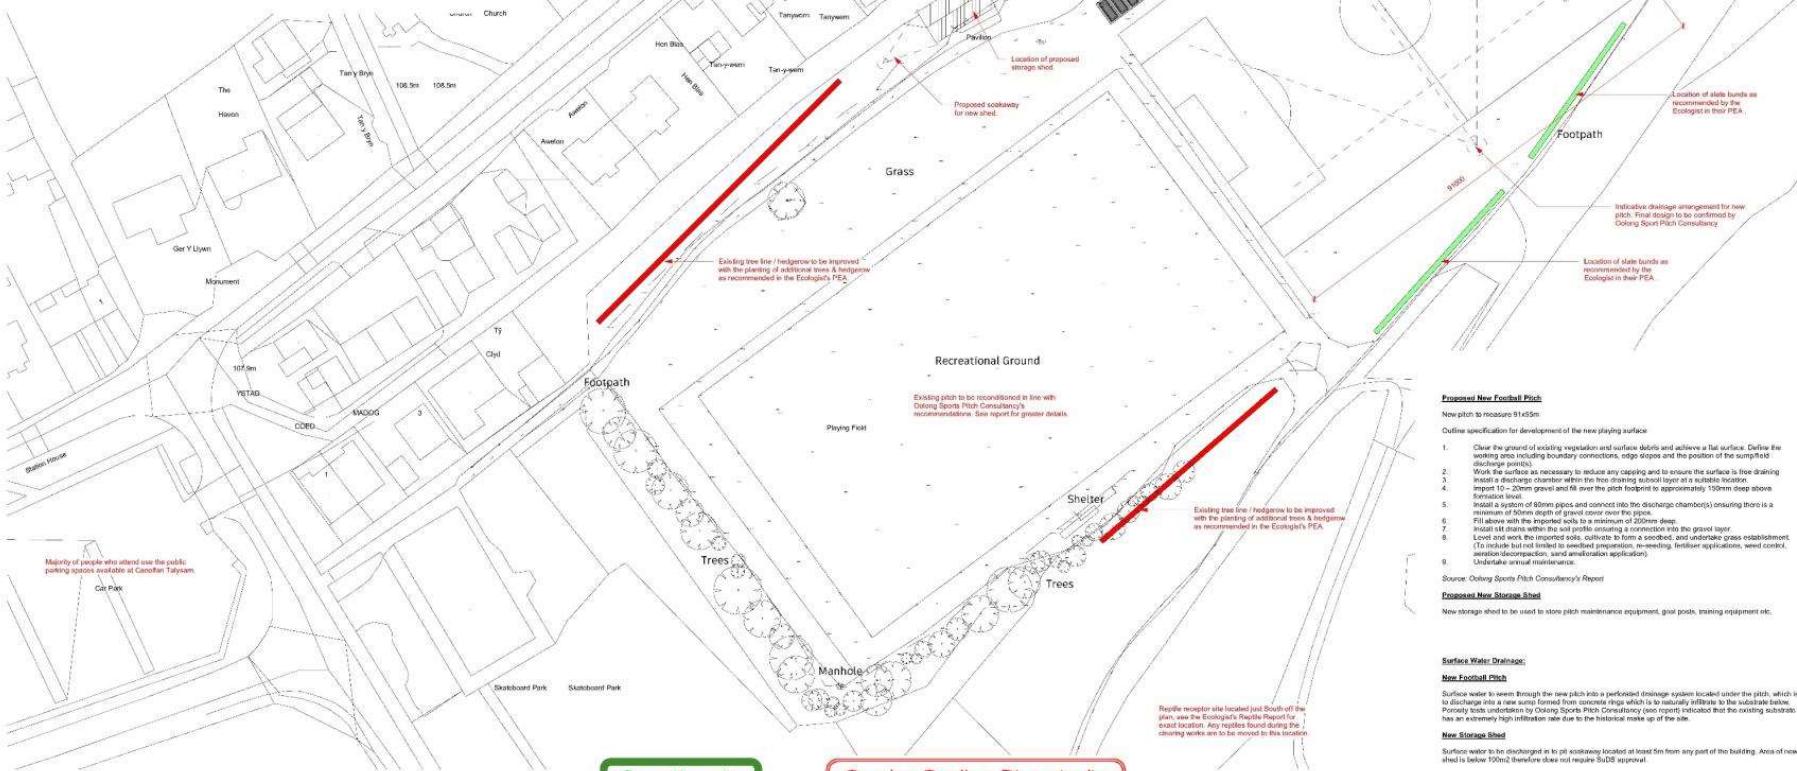
Additional parking provision is to be formed with stone walls which will allow and surface water to penetrate through into the substrate.

**Proposed Materials:**  
Walls - Green box profile cladding  
Roof - Green box profile cladding  
Windows & Doors - Steel
